ControlLogix Controllers Revision 13

Cat. No. 1756-L1, -L1M1, -L1M2, -L1M3, -L55, -L55M12, -L55M13, -L55M14, -L55M16, -L55M22, -L55M23, -L55M24, -L61, -L62, -L63

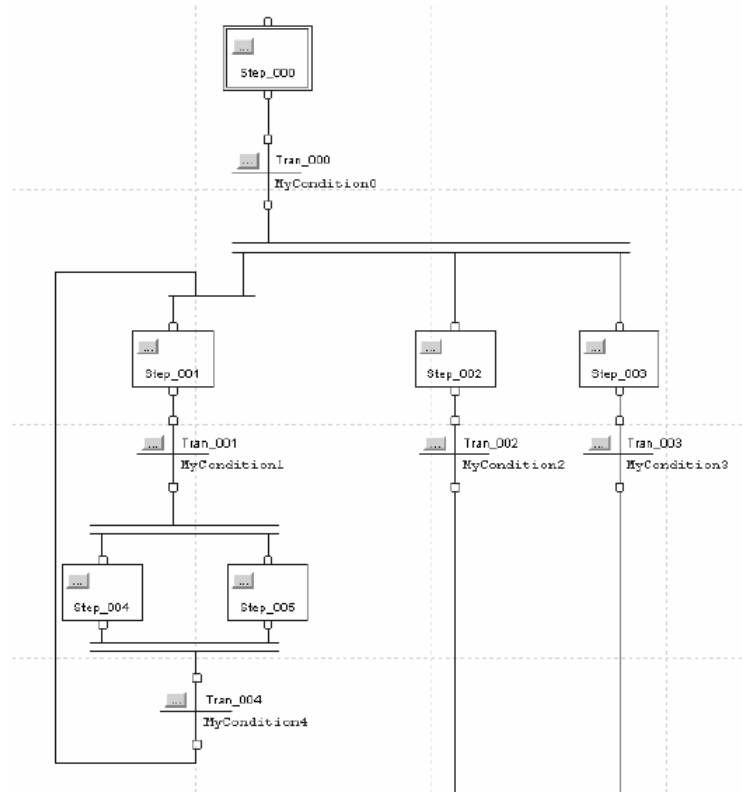
An SFC Could Execute the Wrong Step

If you had an SFC with nested simultaneous branches, the controller could begin execution at an unexpected step. Following the convergence of a nested simultaneous branch, if the SFC looped back to the initial step of the parent branch, instead of executing that step, the SFC could jump to a step of another path in the nested simultaneous branch. For example:

Execution starts at Step_000. When Tran_000 becomes true, Step_001, Step_002 and Step_003 should become active. However, because the nested simultaneous branch in the left path converged and looped back to its parent step (Step_001), the active steps were actually **Step_005**, Step_002 and Step_003.

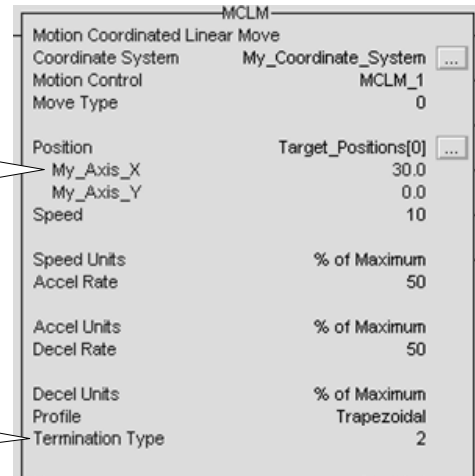
MCLM Instruction Sometimes Caused an Extra Revolution When an Axis Was Near Its Unwind Position

Sometimes a Motion Coordinated Linear Move (MCLM) instruction moved an axis an extra revolution under these conditions:

The axis was rotary. The move was blending with another MCLM instruction across the unwind position.

Termination Type was 2 or 3.

This happened because of internal round-off in the floating point calculations.

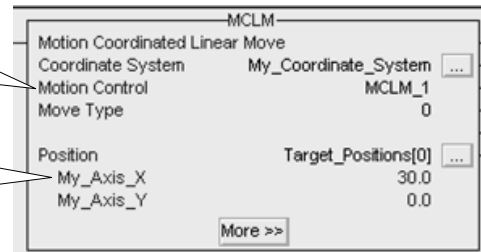
MCLM Instruction Moved an Axis That Was Already at the Target Position

A Motion Coordinated Linear Move (MCLM) instruction moved an axis a full revolution under these conditions:

The Move Type was absolute.

An axis was rotary and it was already at the target position.

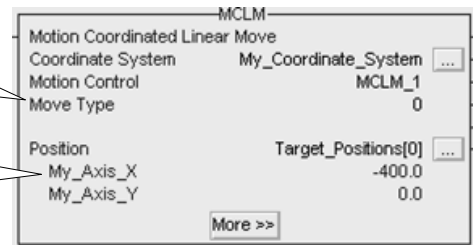
MCLM Instruction Did Not Error with a Target Position Less Than -360°

A Motion Coordinated Linear Move (MCLM) instruction did not error under these conditions:

The Move Type was absolute.

An axis was rotary and its target position was less than -360°

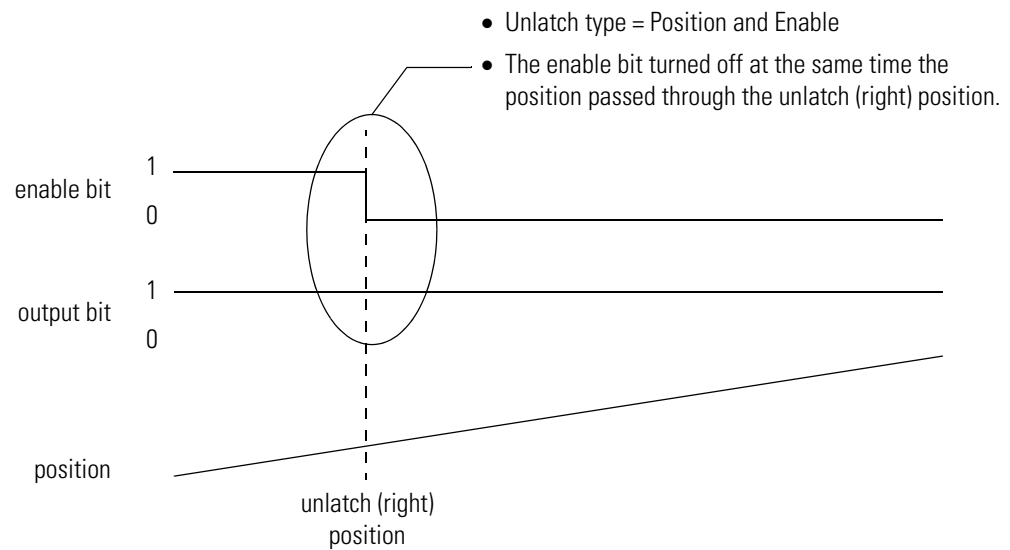
MAOC Instruction Left Output Bit On When Enable Bit Turned Off

Under the following conditions, the Motion Arm Output Cam (MAOC) instruction left the output bit on when the bit should have turned off.

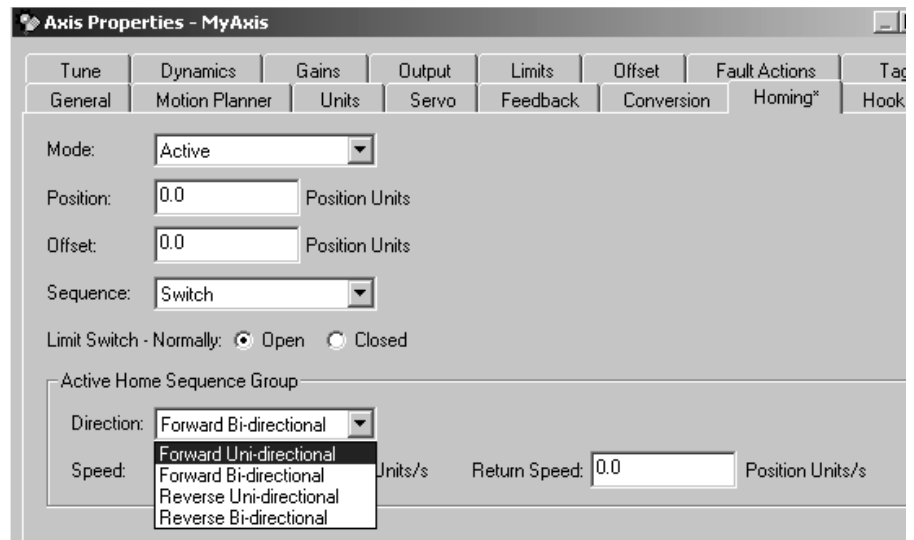
Uni-Directional Homing Failed to Complete

A Motion Axis Home (MAH) instruction sometime failed to complete (IP bit remained on) under the following axis configuration:

- Return Speed = 0
- uni-directional homing (forward or reverse)

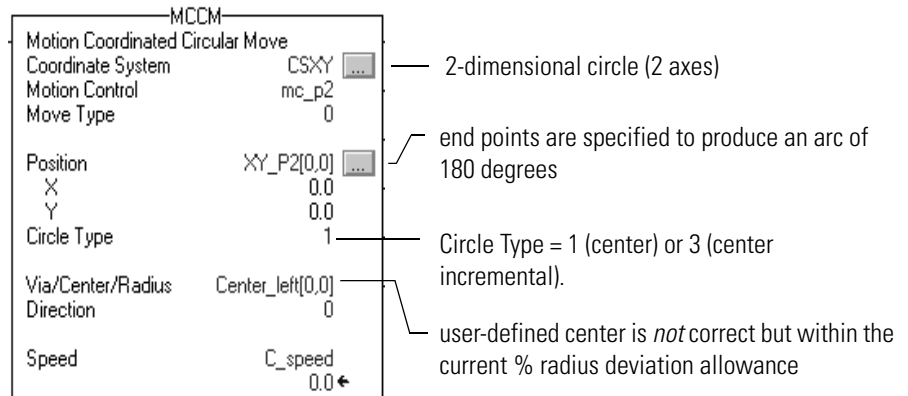
In Circular Center Programming Mode, a Motion Coordinated Circular Move (MCCM) Instruction May Fail to Reach the Specified End Point of a 180 Degree Arc If the Circle Center Is Miss-Programmed.

If you configure a Motion Coordinated Circular Move (MCCM) instruction as shown below, the instruction may *not* produce a move to the specified end points.

To work around this restriction, enter the correct circle center.

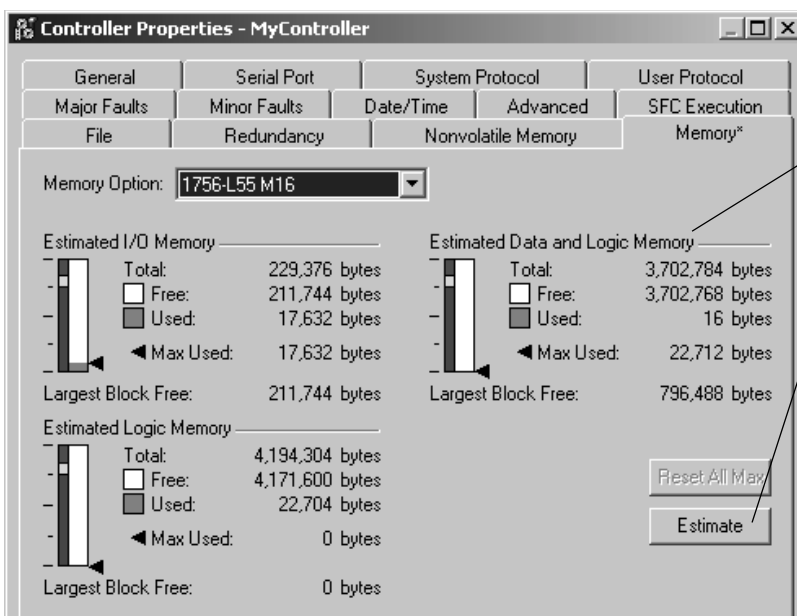
1756-L55M16 controllers—3.5M Byte Limit of Tags

You *cannot* download a project that has more than 3.5M bytes of tags to a 1756-L55M16 controller. During the download, RSLogix 5000 software indicates that the controller is out of memory.

To stay within the 3.5M byte limit, use the Memory tab of the Controller Properties window.:

In general, the data and logic memory represents the 3.5M byte limit for tags.

As you develop your project, periodically go to this tab and click the *Estimate* button.
