## CompactLogix Controller Revision 13

Catalog Numbers 1769-L31, 1769-L32C, 1769-L32E, 1769-L35CR, 1769-L35E

These release notes correspond to:

CompactLogix™ controller:	Firmware revision:
1769-L31, L32C, L35CR	Major revision 13, minor revision 33
1769-L32E, -L35E	Major revision 13, minor revision 34

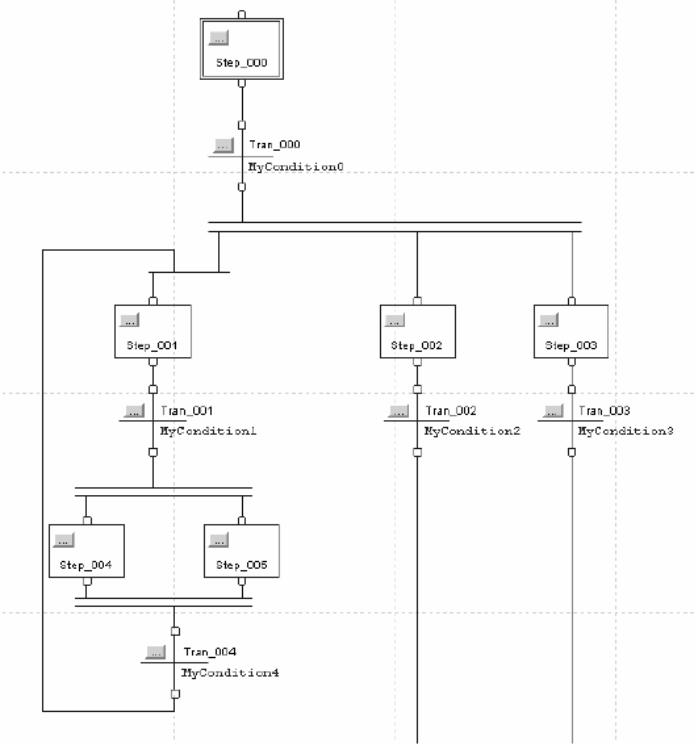
<p>An SFC Could Execute the Wrong Step</p>	<p>If you had an SFC with nested simultaneous branches, the controller could begin execution at an unexpected step. Following the convergence of a nested simultaneous branch, if the SFC looped back to the initial step of the parent branch, instead of executing that step, the SFC could jump to a step of another path in the nested simultaneous branch. For example:</p>

<p>Execution starts at Step_000. When Tran_000 becomes true, Step_001, Step_002 and Step_003 should become active. However, because the nested simultaneous branch in the left path converged and looped back to its parent step (Step_001), the active steps were actually <b>Step_005</b>, Step_002 and Step_003.</p> <p style="text-align: right;">Lgx00054785</p>
<p>The File Search Compare (FSC) Instruction Caused a Non-Recoverable Fault</p>	<p>The FSC instruction caused a non-recoverable fault if both these conditions occurred:</p> <ul style="list-style-type: none"> <li>• a major fault was declared from within the expression of an FSC instruction</li> <li>• the user fault routine cleared the fault</li> </ul> <p>When the user fault routine attempted to recover, information previously saved was not properly restored, which resulted in corrupted system registers and a non-recoverable fault.</p> <p style="text-align: right;">Lgx00055522</p>

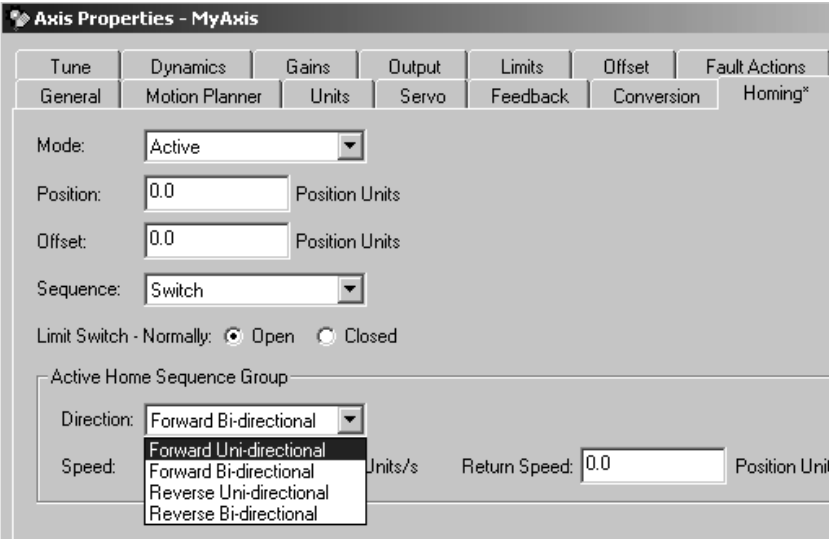
<b>Anomaly:</b>	<b>Description:</b>
<p>uni-directional homing failed to complete</p>	<p>A Motion Axis Home (MAH) instruction sometime failed to complete (IP bit remained on) under the following axis configuration:</p> <ul style="list-style-type: none"> <li>• Return Speed = 0</li> <li>• uni-directional homing (forward or reverse)</li> </ul>

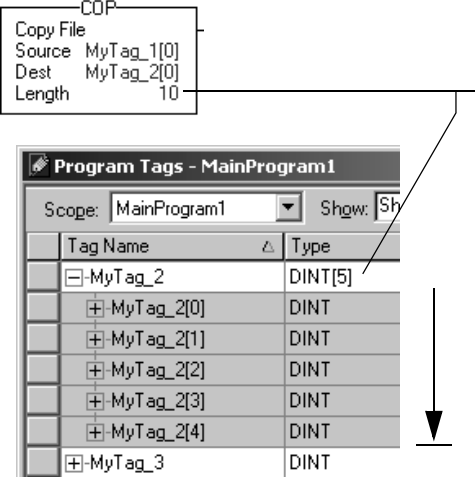
Restriction:	Description:															
<p>In a tag of a user-defined data type, an instruction may write past the end of an array</p>	<p>If you write too much data to an array that is within a user-defined data type, some instructions write beyond the array and into other members of the tag.</p> <p><b>Example 1: Instruction Stops at the End of the Array</b></p>

<p>If the length is greater than the number of elements in the destination array...</p> <p>... the instruction stops at the end of the array.</p> <p><b>Example 2: Instruction Writes Beyond the Array</b></p>

<p>This restriction also applies to <i>all previous revisions</i>. To prevent writing beyond the limits of the destination array, make sure the length operand of the instruction is less than or equal to the number of elements in the array.</p>	BSL	FBC	LFL	BSR	FFL	LFU	COP	FFU	SQL	CPS	FLL	SRT	DDT	GSV	SSV
BSL	FBC	LFL														
BSR	FFL	LFU														
COP	FFU	SQL														
CPS	FLL	SRT														
DDT	GSV	SSV

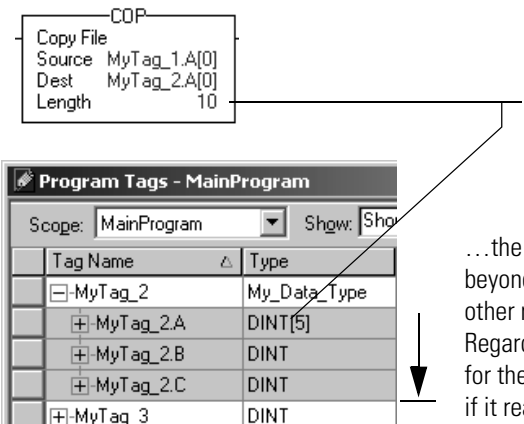
<p>If the length is greater than the number of elements in the destination array...</p> <p>... the instruction writes data beyond the end of the array into other members of the tag. Regardless of the length specified for the instruction, it stops writing if it reaches the end of the tag.</p> <p>The following instructions write beyond the array into other members of the tag:</p>
