ControlLogix Standard Redundancy Firmware, Revision 16.57

Redundancy Module Catalog Numbers

1756-RM, 1757-SRM

Controller Catalog Numbers

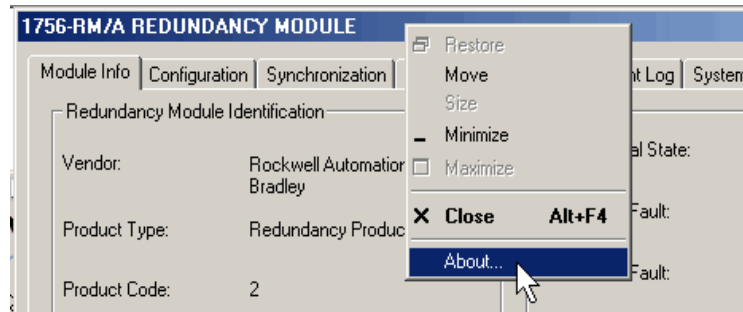
4. Right-click the title bar and choose About.

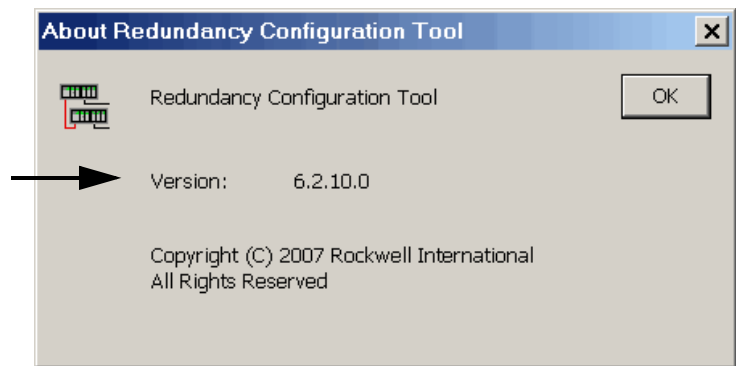
The About dialog box opens and indicates the RMCT version.

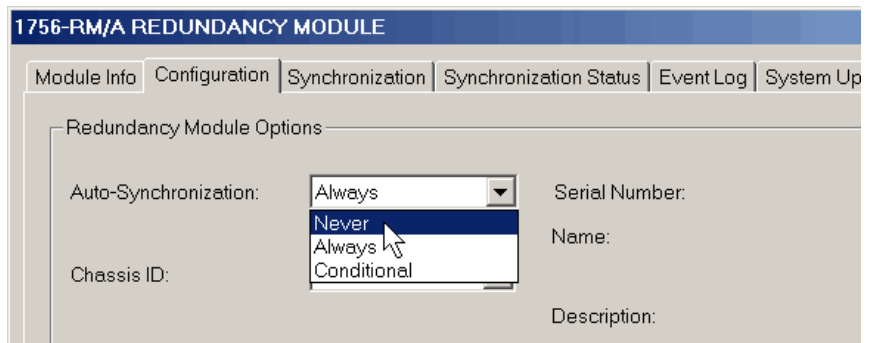
4. Click the Configuration tab.
5. From the Auto-Synchronization pull-down menu, choose Never.

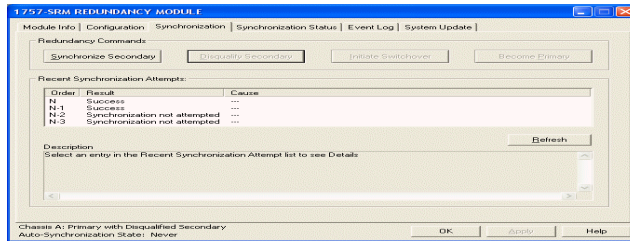
6. Click Apply, then click Yes.
7. Click the Synchronization tab.

8. Click Disqualify Secondary, then click Yes.

The secondary chassis is disqualified as indicated at the bottom-left of the RMCT and on the redundancy module's status display.

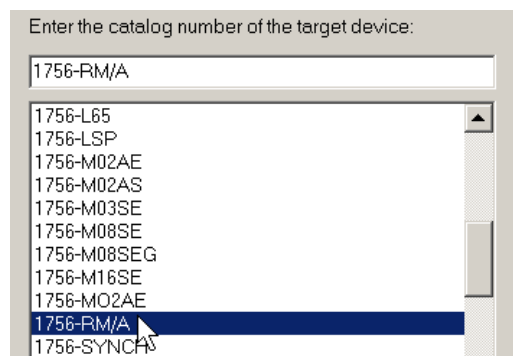
1. Launch ControlFlash software and click Next.
2. Select the redundancy module catalog number and click Next.

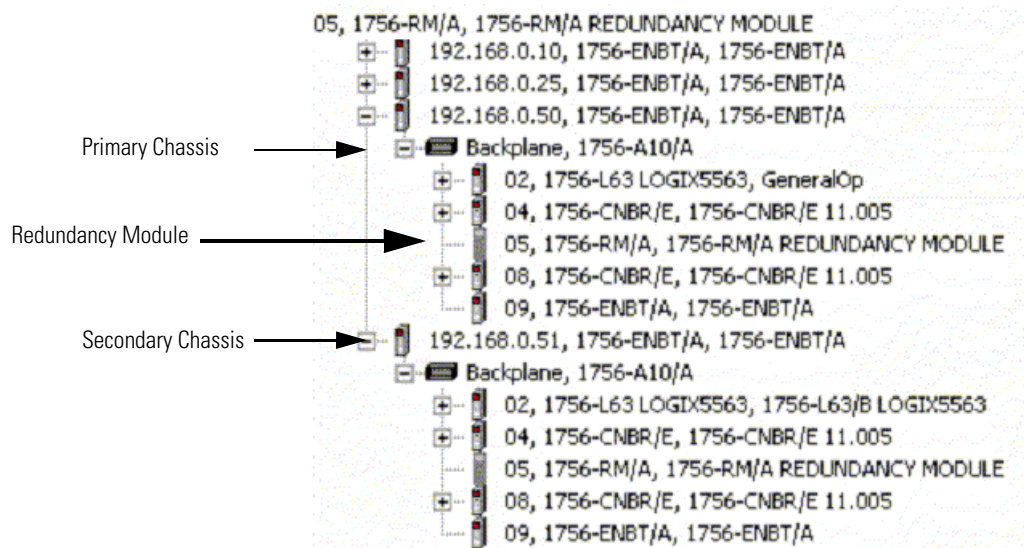
3. Browse to the redundancy module and select it.

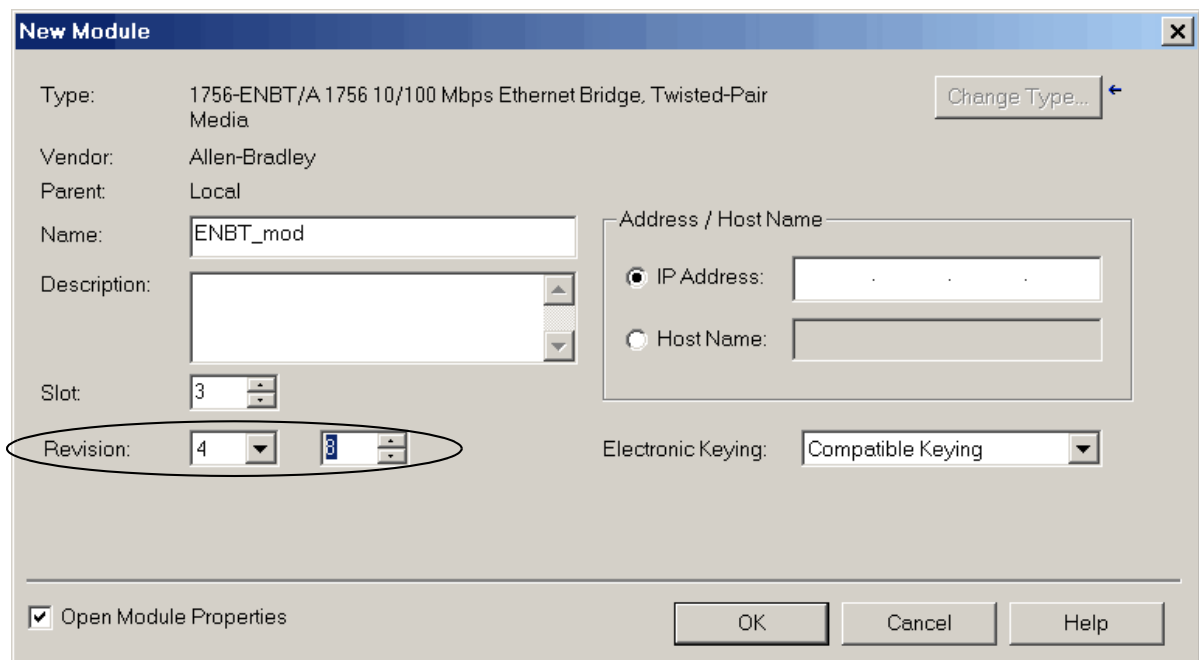
13. Access the Module Properties for each communication module in the chassis and specify the module firmware revision you are upgrading to.

If you are unable to specify the new revision, you may need to change the Electronic Keying parameter to Compatible Keying.

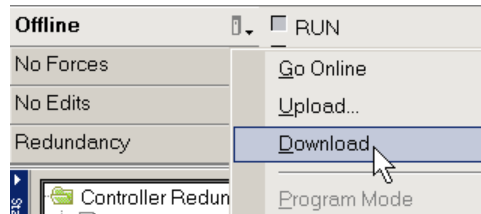
15. Download the project to the secondary controller.

The secondary controller is at the higher network address of the the two available for the redundant chassis.

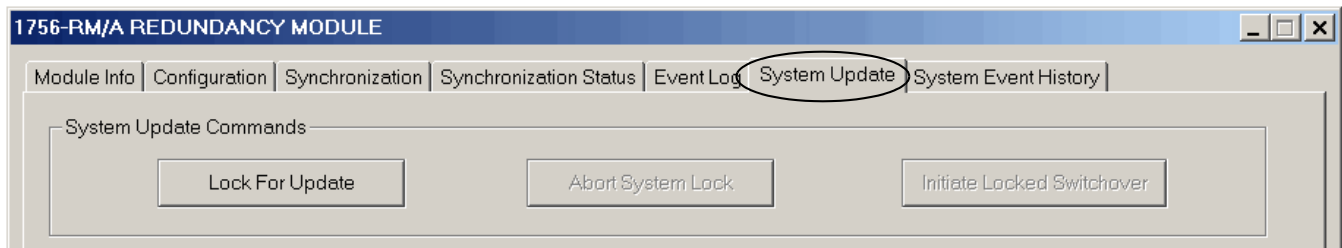
2. Click the System Update tab.

3. Click Lock for Update, then click Yes.
4. Wait for the system to lock.

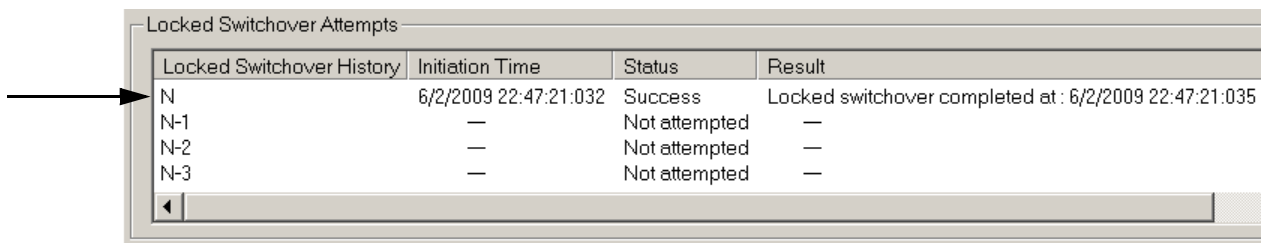
This step results in your secondary chassis assuming control and becoming the primary chassis. When the switchover is complete, the Locked Switchover Attempts log indicates success.

Locked Switchover Attempts			
Locked Switchover History	Initiation Time	Status	Result
N	6/2/2009 22:47:21:032	Success	Locked switchover completed at : 6/2/2009 22:47:21:035
N-1	—	Not attempted	—
N-2	—	Not attempted	—
N-3	—	Not attempted	—

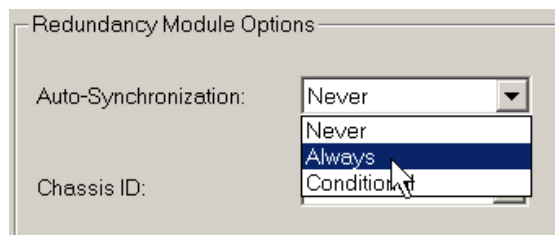
2. Click the Configuration tab.
3. From the Auto-Synchronization pull-down menu, choose the frequency that suits your application.

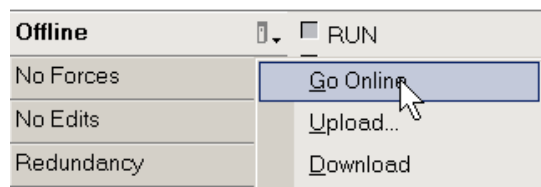
4. In RSLogix 5000 programming software, go online with the secondary controller.
